Air Transportation Safety Investigation Report A1800150

MID-AIR COLLISION

Cessna 150G, C-FGMZ (privately owned)
and
NLG Air Inc.
Piper PA-42 Cheyenne III, C-FCSL
Ottawa/Carp Airport, Ontario, 1.3 nm S
04 November 2018

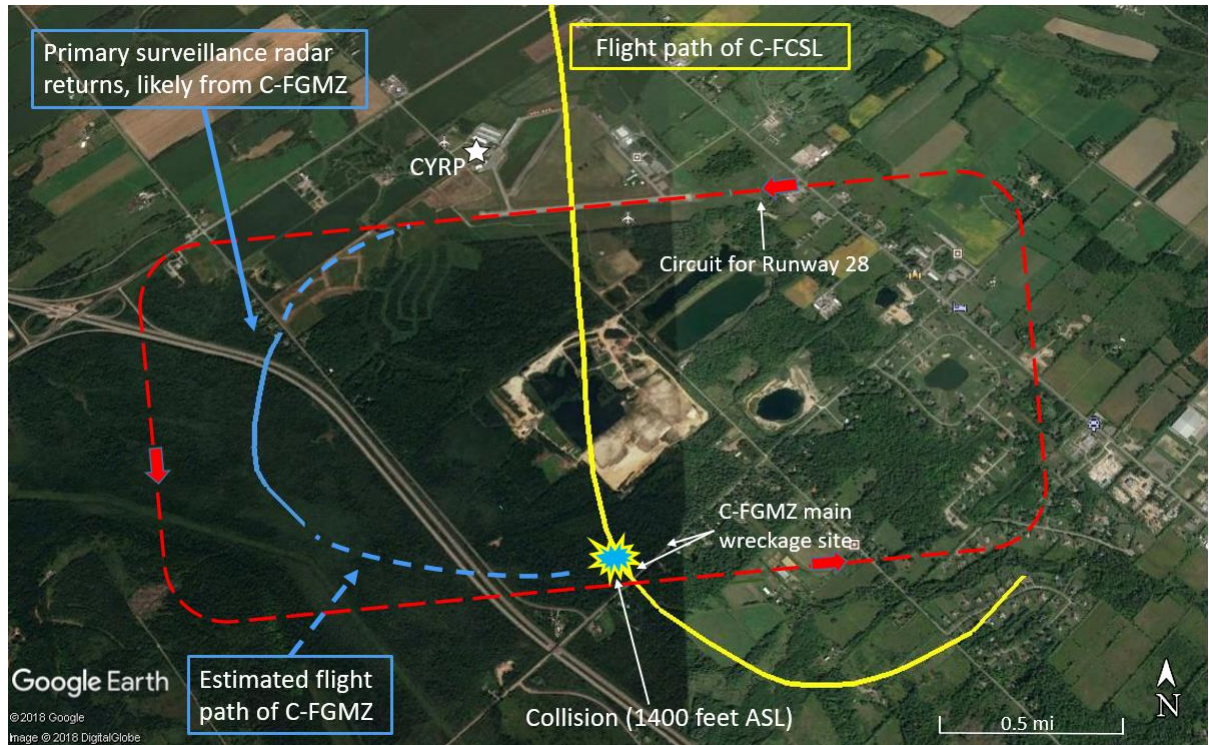
At 1010, the Piper was on approach to the airport from the north. It had flown over Runway 10/28 at circuit altitude to join the circuit at the midpoint of the downwind leg for Runway 28, when the 2 aircraft collided at approximately 1400 feet ASL, about 1.3 nautical miles (nm) south of the airport (Figure 1). The pilot of the Piper did not see the Cessna while crossing over the airport. The investigation was unable to determine whether the pilot of the Cessna saw the Piper or took evasive action prior to the collision.

Figure 1. Flight paths of the Piper (C-FCSL) and the Cessna (C-FGMZ). The left-wing outboard section of C-FGMZ was found 635 feet southwest of the main wreckage site. (Source: Google Earth, with TSB annotations)

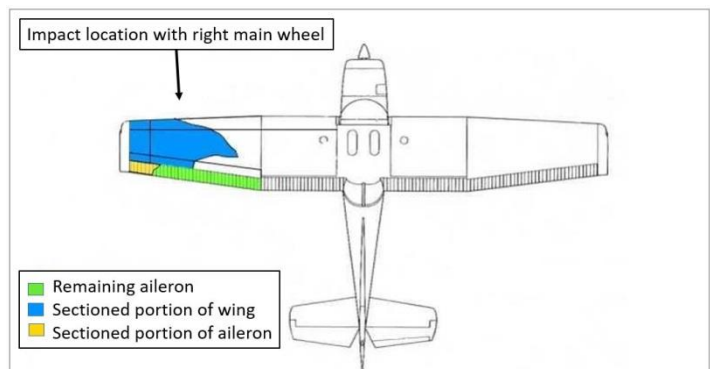
The investigation determined that, as the 2 aircraft collided, the Cessna's left wing struck the Piper's extended right main-wheel assembly at a point 5.75 feet from the Cessna's outer left-wing rib. The impact damage to the leading edge of the wing indicates that it struck the outboard face of the Piper's wheel assembly, nearly perpendicular with the Piper's longitudinal axis.

The damage sustained by the wing structure caused the failure and subsequent separation of the outer section of the wing and aileron (Figure 2). The aircraft became uncontrollable and rapidly entered a steep dive, striking the ground in a near-vertical attitude. The aircraft was destroyed by the impact forces and post-impact fire.

Figure 2. The Cessna's in-flight damage (Source: Cessna Aircraft Company, with TSB annotations)

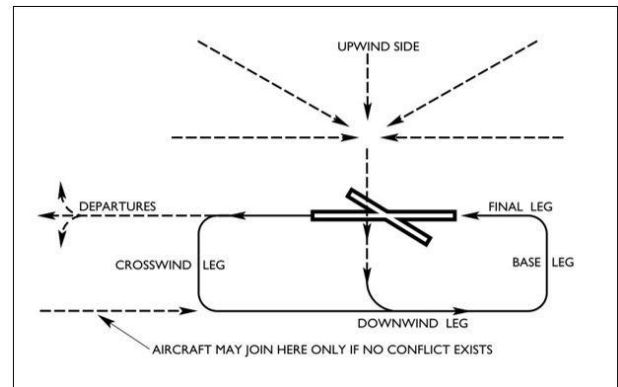
All pilots “operating at or in the vicinity of an aerodrome shall observe the aerodrome traffic for the purpose of avoiding a collision”⁷ and “are expected to approach and land on the active runway.”⁸ In addition, at aerodromes that are not within a mandatory frequency (MF) area,⁹ aircraft “should approach the traffic circuit from the upwind side”¹⁰ (Figure 3).

Figure 3. Standard left-hand circuit pattern at an uncontrolled aerodrome (Source: Transport Canada, TP 14371E, *Transport Canada Aeronautical Information Manual* [TC AIM], RAC—Rules of the Air and Air Traffic Services [11 October 2018], Figure 4.6.)
