AIR TRANSPORTATION SAFETY INVESTIGATION REPORT A18W0116

POWER LOSS AND LOSS OF CONTROL IN FLIGHT

Aries Aviation International
Piper PA-31, C-FNCL
Calgary/Springbank Airport, Alberta, 40 nm SW
01 August 2018

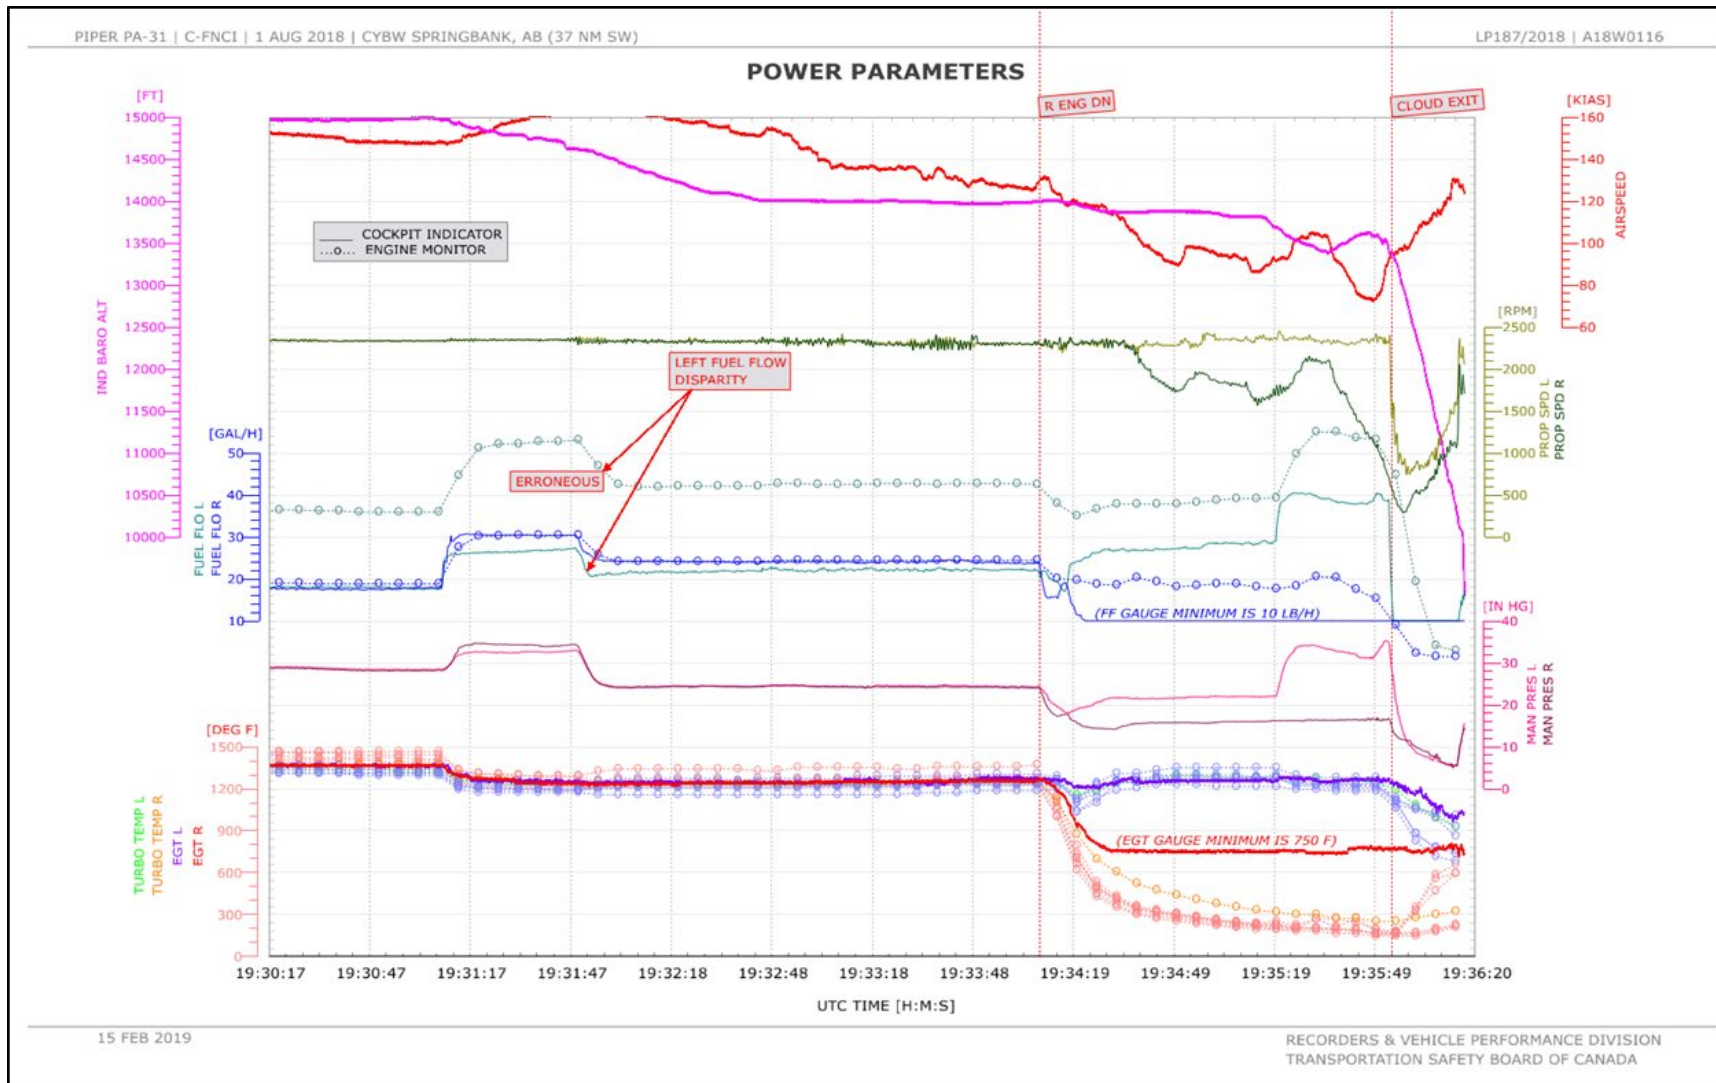
A few seconds later, the manifold pressure (MP) on both engines decreased, which resulted in the left-hand MP gauge indicating an MP of 18 inches of mercury (inHg) and a fuel flow of 22 U.S. gallons per hour, and the right-hand engine indicating an MP of 15 inHg and a fuel flow of 14 U.S. gallons per hour.

The aircraft exited the clouds at 13 300 feet. Shortly afterward, the engine fuel-flow monitors indicated idle fuel flow, or about 4.5 U.S. gallons per hour, for each engine. Commensurate with the power reduction and decrease in airspeed, the rpm of both engines decreased. When the right engine reached 700 rpm, the right-alternator failure (R ALT INOP) warning light illuminated on the annunciator panel, followed immediately by both the left- and right-pneumatic-source failure (L PNEU INOP and R PNEU INOP) warning lights. As the airspeed increased to 110 KIAS in the spin, the rpm of both engines also increased. When the aircraft reached 110 KIAS, the right-alternator failure warning light went out, followed by the right and then the left pneumatic-source failure warning lights.

Figure B1. Parameters for the last 6 minutes of the flight (Source: TSB Engineering Laboratory)
