AIR TRANSPORTATION SAFETY INVESTIGATION REPORT A18Q0030

RUNWAY OVERRUN ON LANDING

Strait Air (2000) Ltd.
Beechcraft King Air A100, C-GJXF
Havre St-Pierre Airport, Quebec
26 February 2018

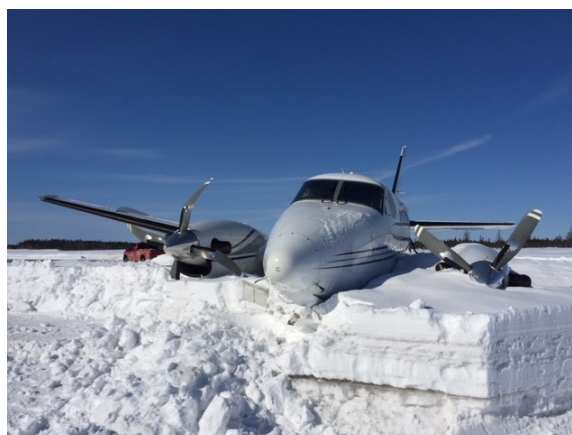
Figure 2. Wreckage of the occurrence Beechcraft King Air A100 (Source: TSB)

The force of the impact with the snowbank caused the propellers to halt abruptly and the blades to bend backward. It also caused substantial damage to the left landing gear and wings (Figure 2).

Despite the substantial damages to the landing gear and the wing structure caused by the impact with the snowbank, the deceleration forces did not jeopardize occupant survivability.⁴⁵ However, half of the occupants received minor injuries.

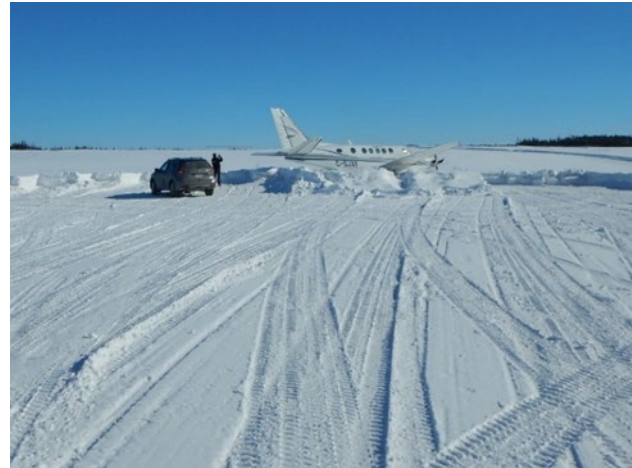
Figure 6. Position of the wreckage at the end of the runway (Source: TSB, photo taken 2 days after the accident)

When they arrived on the scene, TSB investigators noted that the flaps were raised, the fuel system was cut and the electrical system was off. The pitch of both propellers was practically zero (0°), and all of the propeller blades were bent backwards. The landing gear collapsed and bent backwards, and the engine air inlets were blocked by compacted snow.

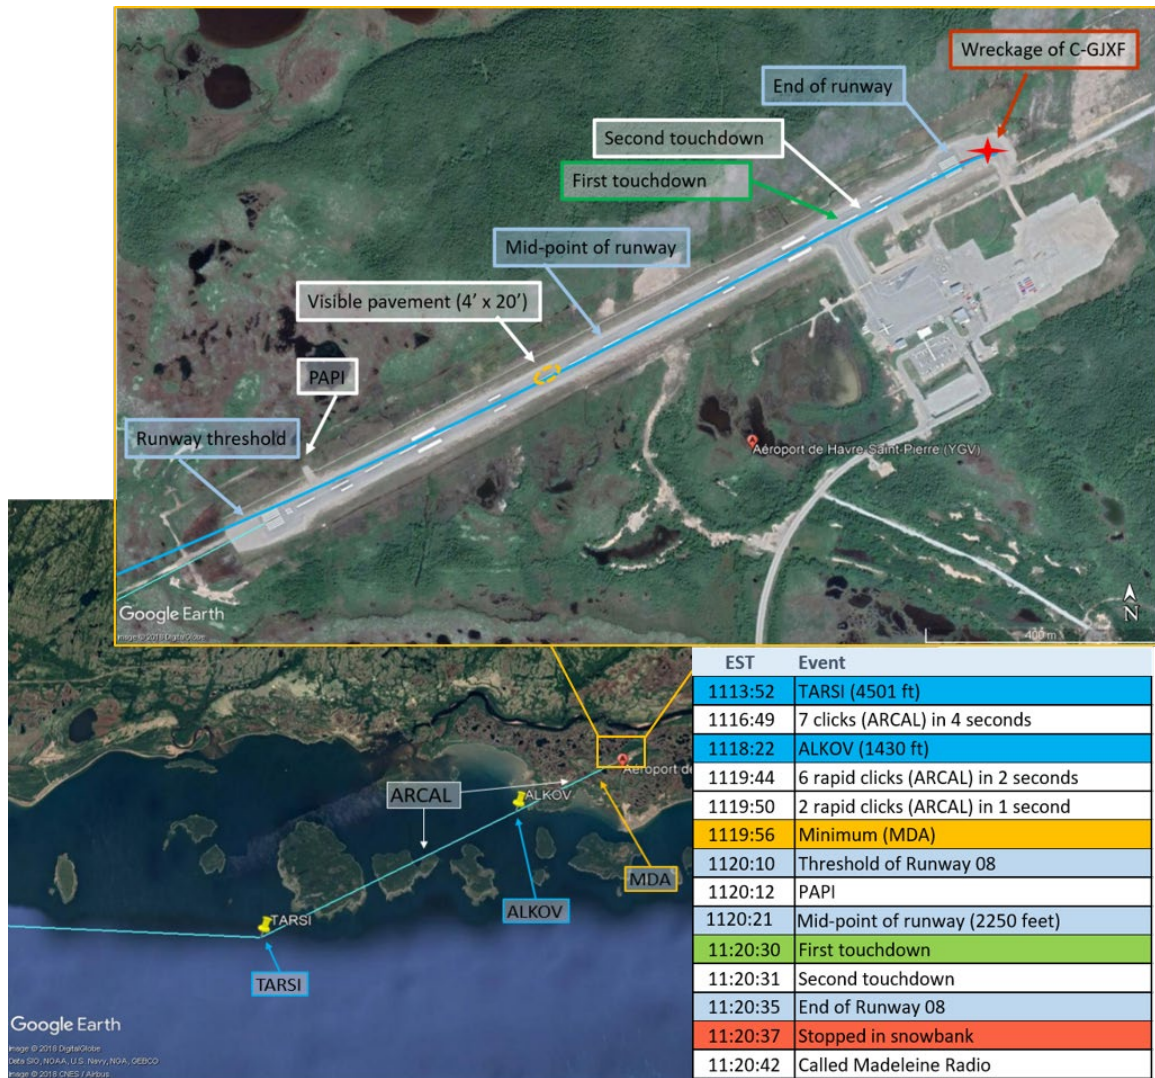
Figure 7. Approach path of the aircraft on final and over the runway (Source: Google Earth, with TSB annotations)

Given the lack of GPS data, the aircraft's approach and landing path was calculated using radar data, recordings of conversations with ATC, observation of the touchdown point, and testimonies. These calculations assisted in determining the aircraft's position and speed during approach, the moment when the aircraft crossed the runway threshold and the length of time the aircraft was flying over the runway before touching down (Figure 7).
