AIR TRANSPORTATION SAFETY INVESTIGATION REPORT A19O0089

LOSS OF CONTROL AND COLLISION WITH TERRAIN

Hawk Air (705833 Ontario Ltd.)
de Havilland DHC-2 Mk. I (Beaver), C-FBBG
Hawk Junction Water Aerodrome, Ontario
11 July 2019

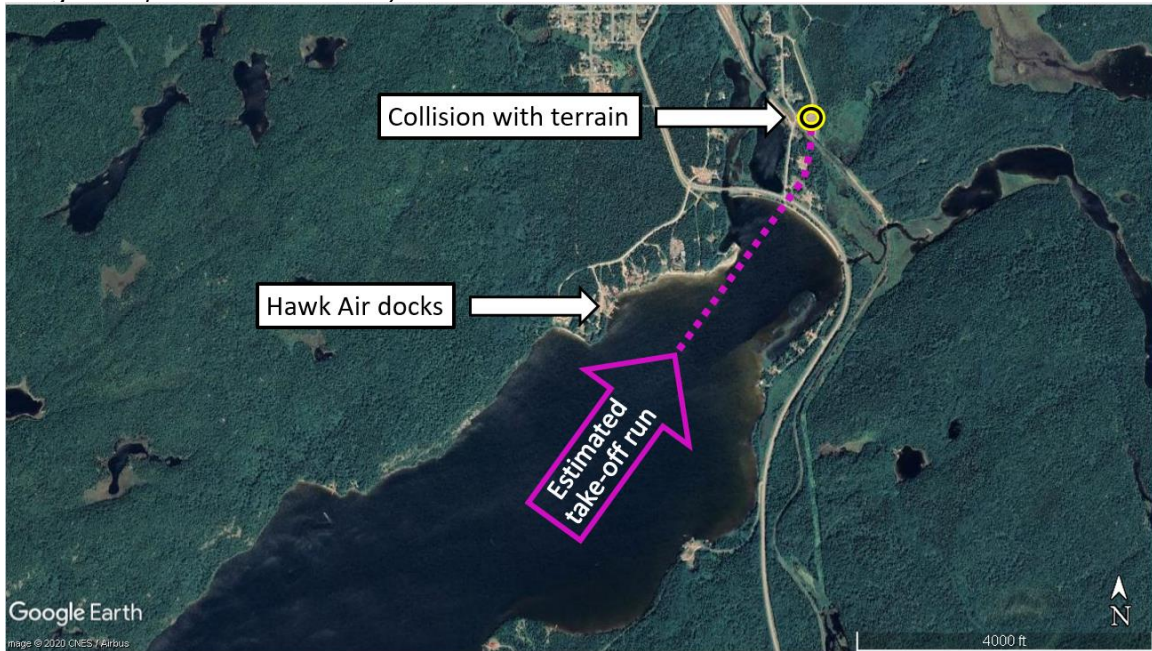
At approximately 0852, the aircraft began its take-off run. It became airborne approximately abeam the Hawk Air dock (Figure 1), and climbed to an estimated height of 300 to 400 feet above ground level (AGL). The aircraft was observed to be climbing normally before entering a sudden left bank and an extreme nose-down attitude.

Figure 1. View of occurrence site, with dashed magenta line showing estimated flight path (Source: Google Earth, with TSB annotations)
