#### **COSPAS-SARSAT SYSTEM OVERVIEW**

## **AIREON SYSTEM OVERVIEW**

## **HOW THE SYSTEM WOULD WORK**

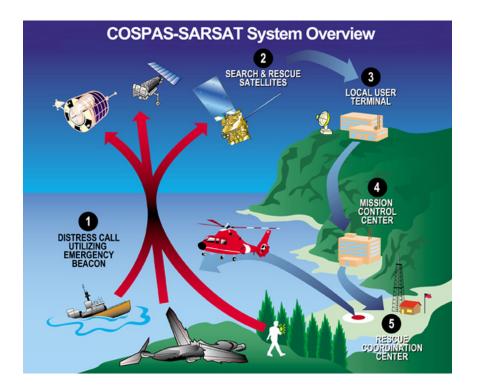
- 1. Emergency beacon activated
- 2. Alerts received by satellites are retransmitted to 38 automatic LUT worldwide
- 3. Alerts are routed to a mission control centre in the country that operates the LUTs
- After validation processing alerts are relayed depending on beacon location or country of registration (406 beacons) to either another MCC or to the appropriate Rescue Coordination Centre (JRCC)

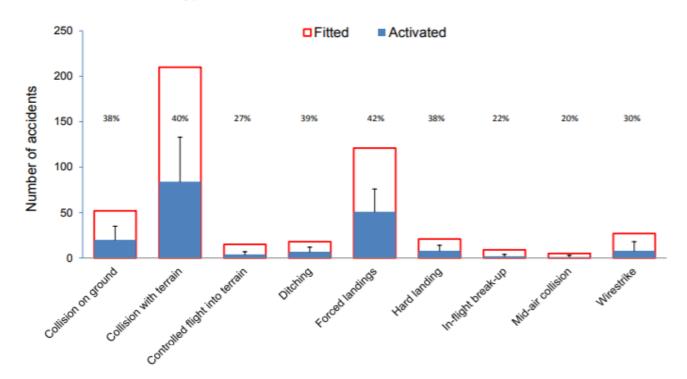
Figure 6: Number of fitted ELTs which activated for high g-force accidents by occurrence type, 1993 to 2012

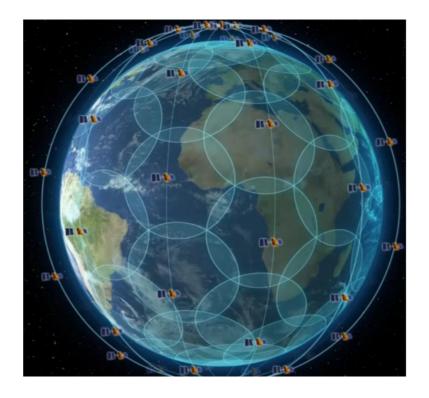
- > Satellites in orbit: 66
  - > 11 satellites per plane
  - Plus 9 in-orbit spare satellites and 6 ground spare satellites
- > Orbital Planes: 6
- > Operational altitude: 780 km
- **>** Availability: ≥ 0.999
- ➤ Latency ≤ 2s\
- ➤ 8s Update Interval ≥ 96%

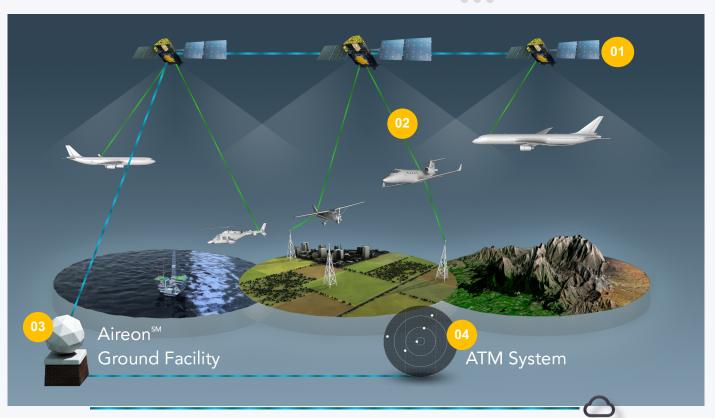
## How does it work?

Aireon will place ADS-B receivers on the Iridium NEXT constellation, which consists of 66 Low Earth Orbit (LEO) satellites.

This space-based ADS-B receiver network will relay signals from all ADS-B equipped aircraft to controllers worldwide, allowing 100 percent global air traffic surveillance regardless of terrain, location or infrastructure.

The surveillance data is relayed directly to the Air Navigation Service Provider (ANSP) in order to manage the air traffic.

The surveillance data is also being sent to Cloud computing resources for creating flights for the purposes of billing analysis.

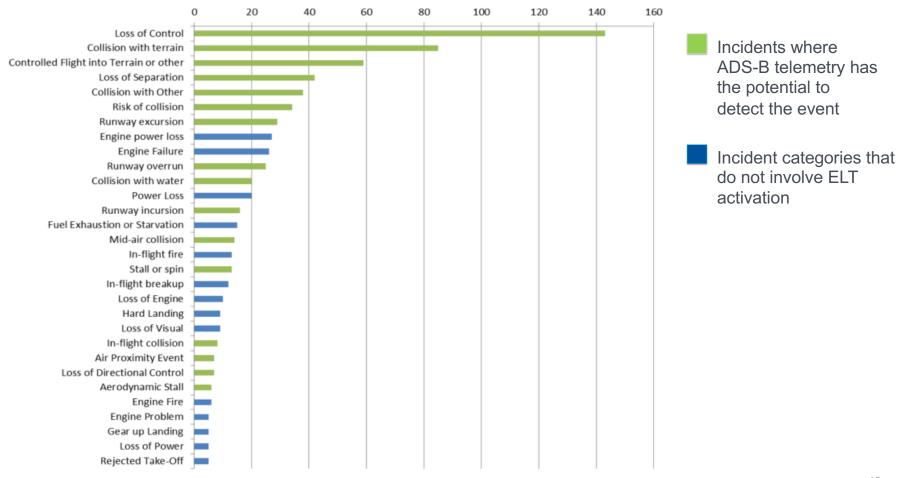
#### **TYPES OF INCIDENTS AND POTENTIAL APPLICABILITY**

Type of Incident	Factors or Reference Data that can be input to automatically detect potential problems with flight
Loss of Control	Sudden, unexpected, erratic manoeuvres
Collision with Terrain	<ul> <li>Last point far away from destination</li> <li>High vertical speed prior to end of flight</li> </ul>
Collision with water	<ul> <li>High vertical speed prior to end of flight</li> <li>Last point is on water (not suitable for type)</li> </ul>
All	<ul> <li>Aircraft type lookup based on ICAO code</li> <li>Aerodrome locations</li> </ul>

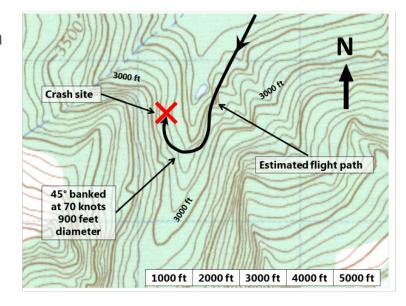
#### **EXAMPLE 1: PILOT TRAINING FLIGHT**

- ➤ Aircraft on flight itinerary from small aerodrome to training area
- Spins and stalls show anomalous flight behaviour within a designated training area

- ➤ A-LIVE system detects flight track ends considerable distance away from aerodrome of departure
- > High vertical speed calculated near ground
- ➤ Airspeed was close to aerodynamic stall speed of aircraft
- Low/no airspeed and anomalous flight behavior prior to end of flight
- > Sends alert continuously to CMCC

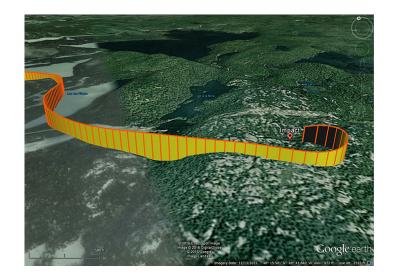
#### **EXAMPLE 2: SKI PLANE LANDING ON RIVER**

- > Ski plane attempts to land on icy river but could not stop its run.
- > Pilot tried to avoid collision with camp, pulled up, ice gave way and aircraft sank.
- > 3 occupants exited aircraft but since it was sinking, decided to swim to shore.
- One of the occupants went missing in the current. The pilot and the second passenger suffered hypothermia.
- > The accident was reported by TC.
- > No ELT activated, no flight plan.

- > A-LIVE system detects abnormal manoeuvres just prior to end of flight.
- > System detects abrupt decrease of airspeed for type of aircraft.
- System send alert continuously to CMCC.
