AIR TRANSPORTATION SAFETY INVESTIGATION REPORT A18Q0030

RUNWAY OVERRUN ON LANDING

Strait Air (2000) Ltd.
Beechcraft King Air A100, C-GJXF
Havre St-Pierre Airport, Quebec
26 February 2018

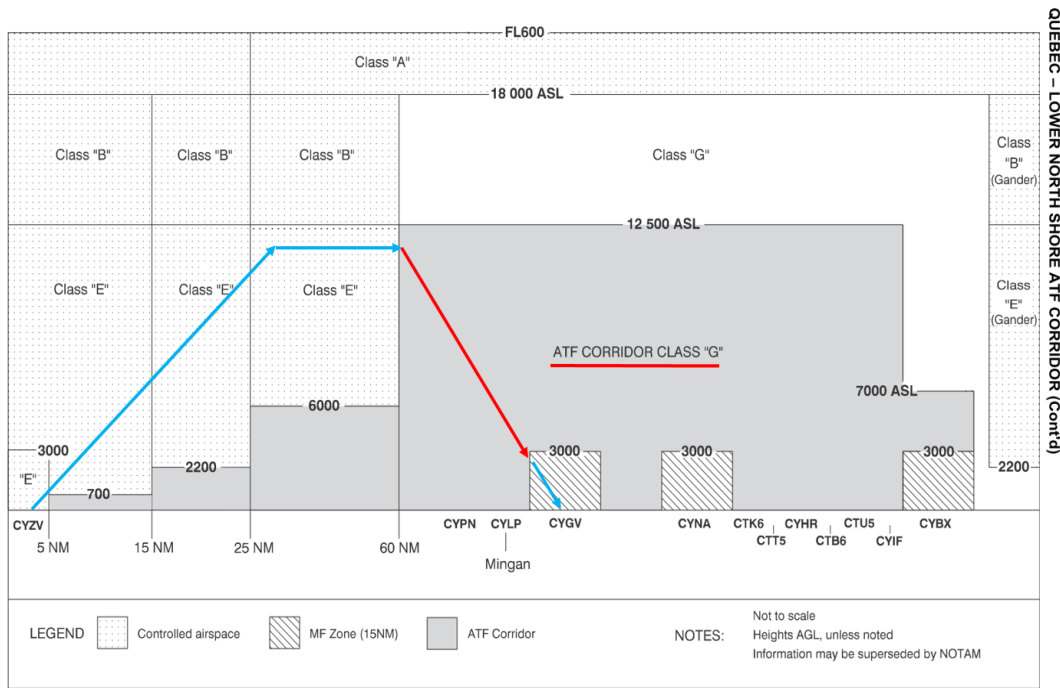
Figure 3. Aircraft’s path between the Sept-Îles and Havre St-Pierre airports: the absence of communications in the aerodrome traffic frequency corridor is shown in red (Source: NAV CANADA, Canada Flight Supplement, effective 01 February 2018 to 29 March 2018, Planning section, p. C98, with TSB annotations)
